Report No. A-CT-61-28

EFFECT OF THERMAL RADIATION ON THE INTEGRITY OF PRESSURIZED AIRCRAFT EVACUATION SLIDES AND SLIDE MATERIALS

FINAL REPORT

MARCH 1981

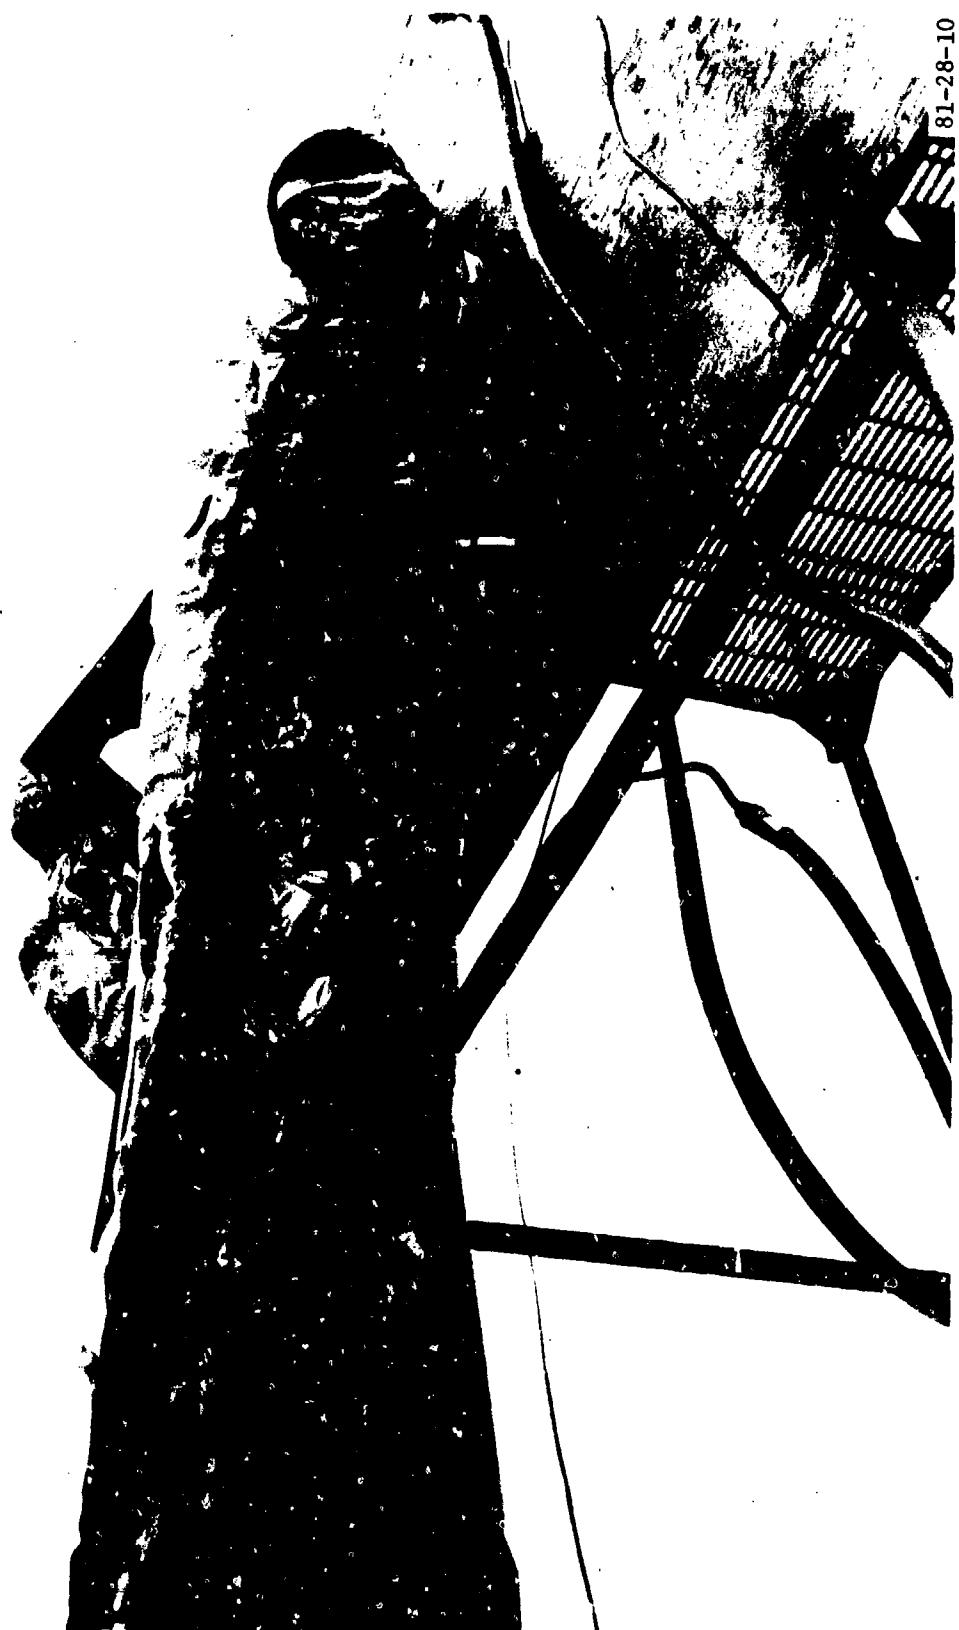
middle of the tube facing the fire. By 64 seconds, at a pressure of 0.5 psig, the uncoated slide blew out in a nonseam area approximately 3 feet below the aspirator on the tube facing the fire (see figure 11). The measured radiative heat flux levels are shown in figure B-12. Although the heat flux values are slightly less than in test 3, which also exposed a double-lane urethane nylon slide at 15 feet from the fire, the onset of failure from this test is consistent with test 3.

FIGURE 11. URETHANE NYLON NONSEAM FAILURE; TEST 16A

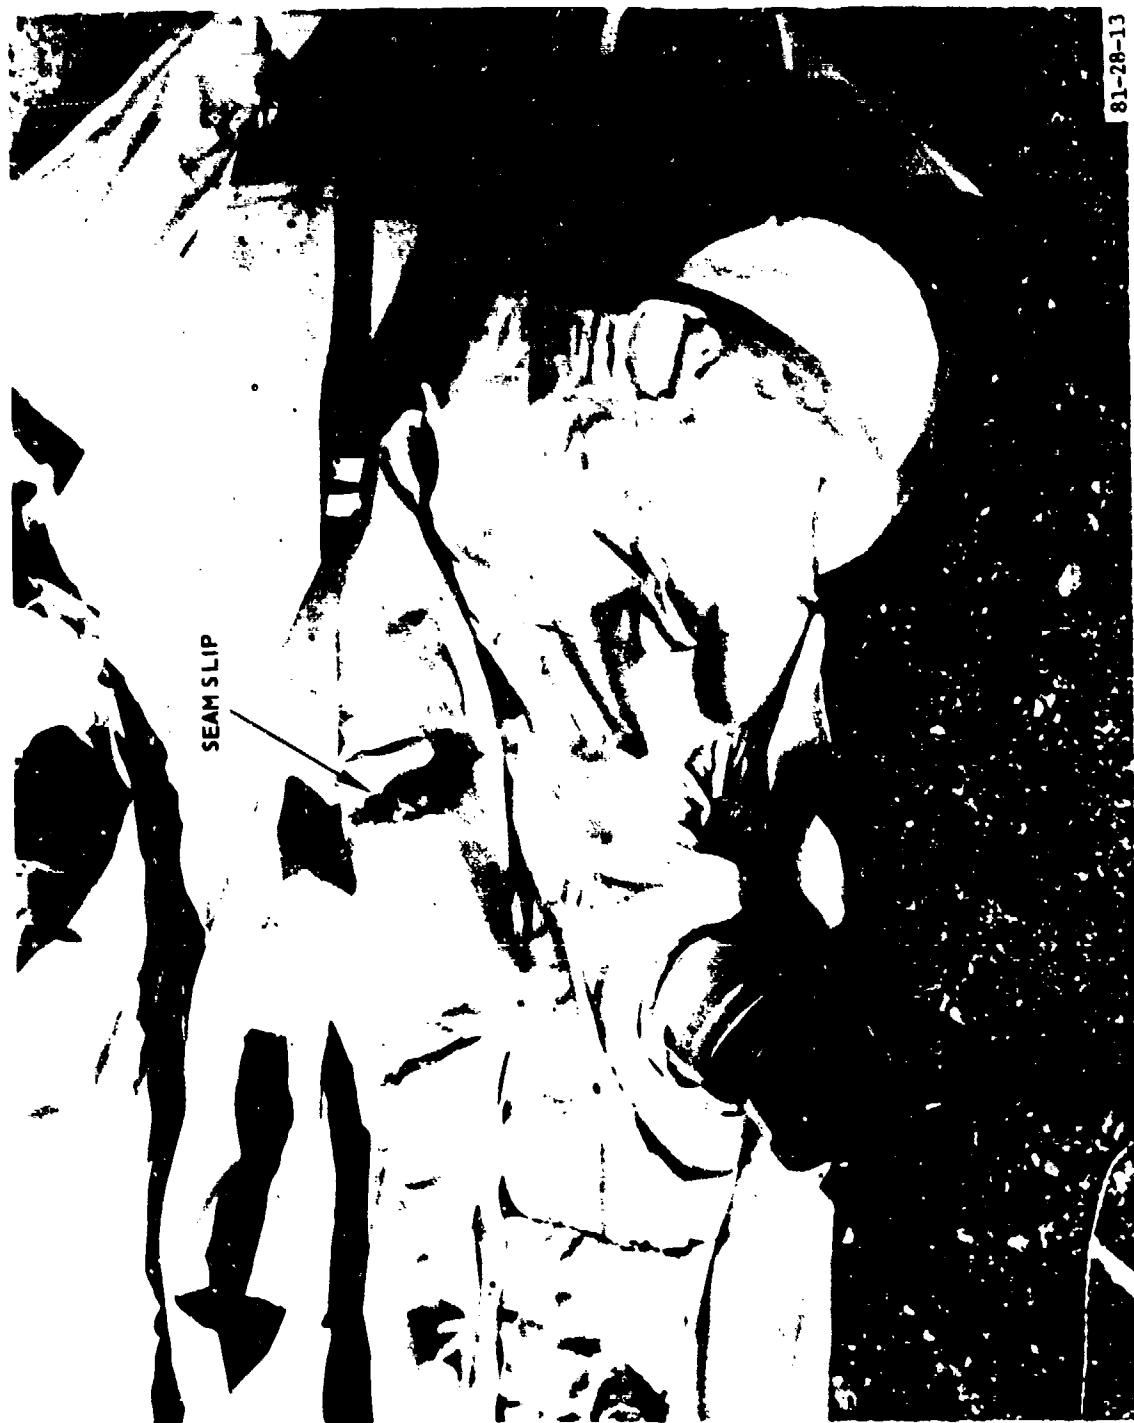
At 58 seconds into the test, seam slippage occurred near the top of the slide on a rounded corner of the upper retaining tube ("armrest") (see figure 14). The slide visually began to collapse at 85 seconds. The peak heat fluxes for the low, medium, and high calorimeters were 1.75 Btu/ft²-sec, 1.65 Btu/ft²-sec, and 1.25 Btu/ft²-sec, respectively (figure B-15). The average heat fluxes for the low, medium, and high calorimeters were 1.2 Btu/ft²-sec, 1.22 Btu/ft²-sec, and 0.85 Btu/ft²-sec, respectively (refer to appendix B-15). This test indicated that seam failure limited the potential heat resistance improvements provided by an aluminized coating applied to a

FIGURE 14. ALUMINIZED URETHANE NYLON SEAM SLIPPAGE; TEST 19

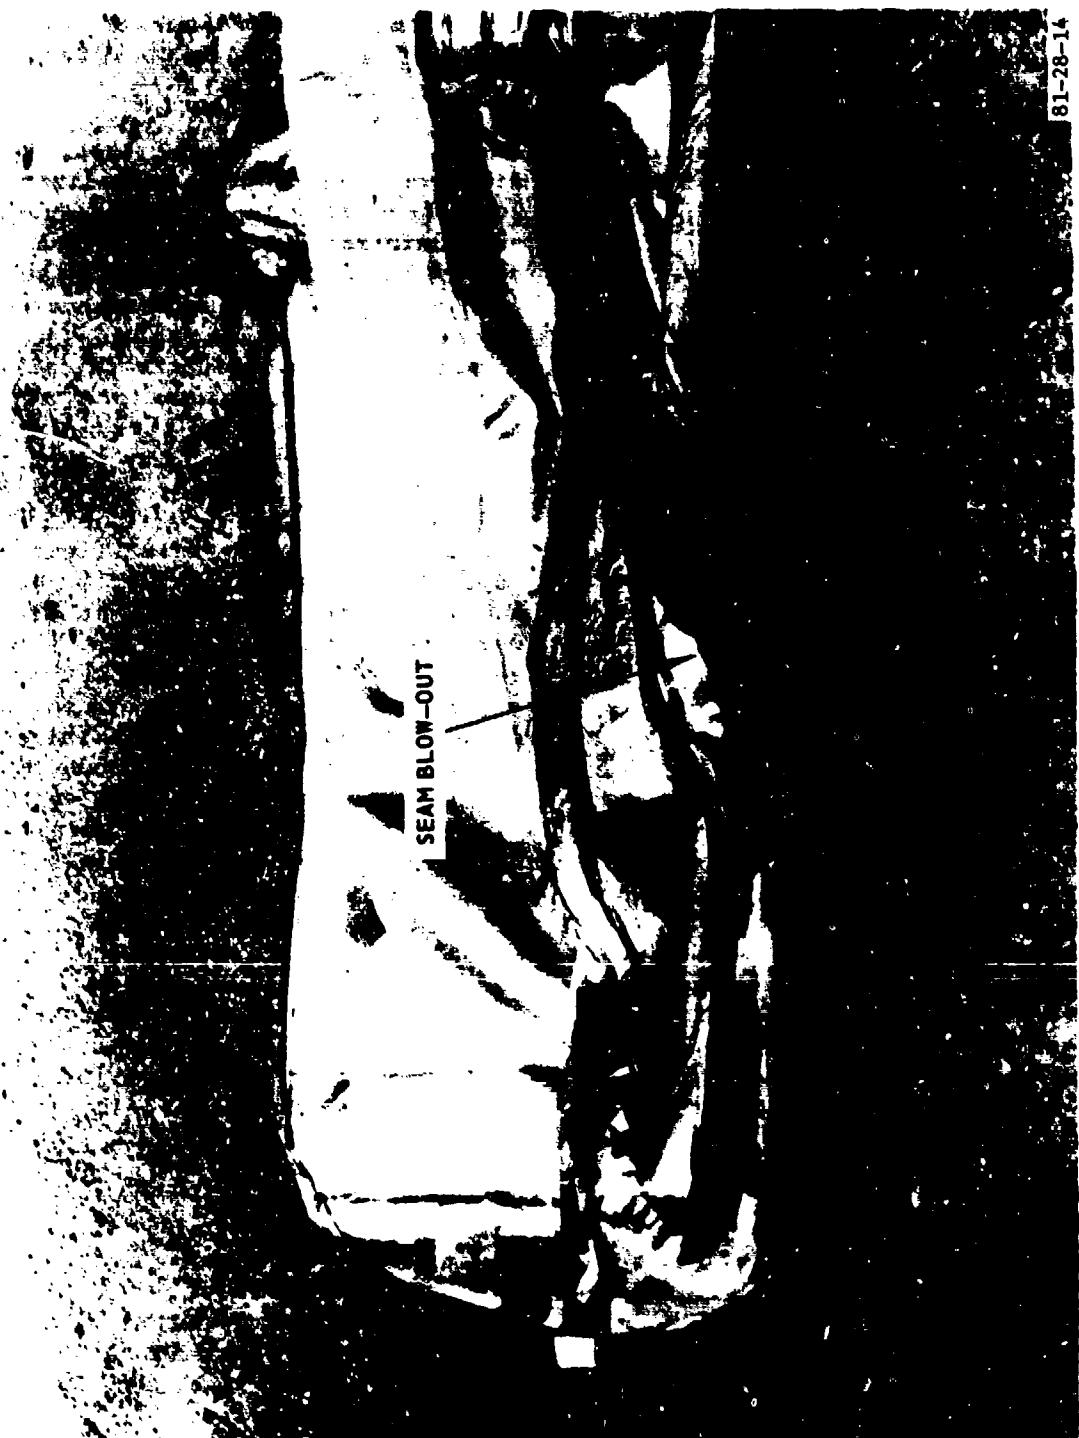
At 49 seconds into the test, the slide reached a peak pressure of 4.1 psig and blew out catastrophically on a seam near the base of the tube facing the fire (see figure 15). The peak heat fluxes for the low, medium, and high calorimeters were 0.9 Btu/ft²-sec, 0.8 Btu/ft²-sec, and 1.1 Btu/ft²-sec, respectively, all recorded at 45 seconds (figure B-16). At these heat flux levels, it was expected that the aluminized neoprene nylon slide would have resisted the fire for a longer period of time. No visible radiant heat damage was noted in the middle and top areas of the slide, in spite of the highest heat flux levels at the top of the slide. Other seam areas near the base of the slide also showed no visible radiant heat damage. It was therefore concluded that the seam in the failure area contained some sort of flaw. The temperature rise for the top side of the sliding surface was 47° F by 49 seconds.

FIGURE 15. ALUMINIZED NEOPRENE NYLON SEAM FAILURE; TEST 20
